Little Atlin Lake Pike Habitat Mapping and Water Temperature Monitoring

EDI Project

23Y0105
Version: 1
February 2024

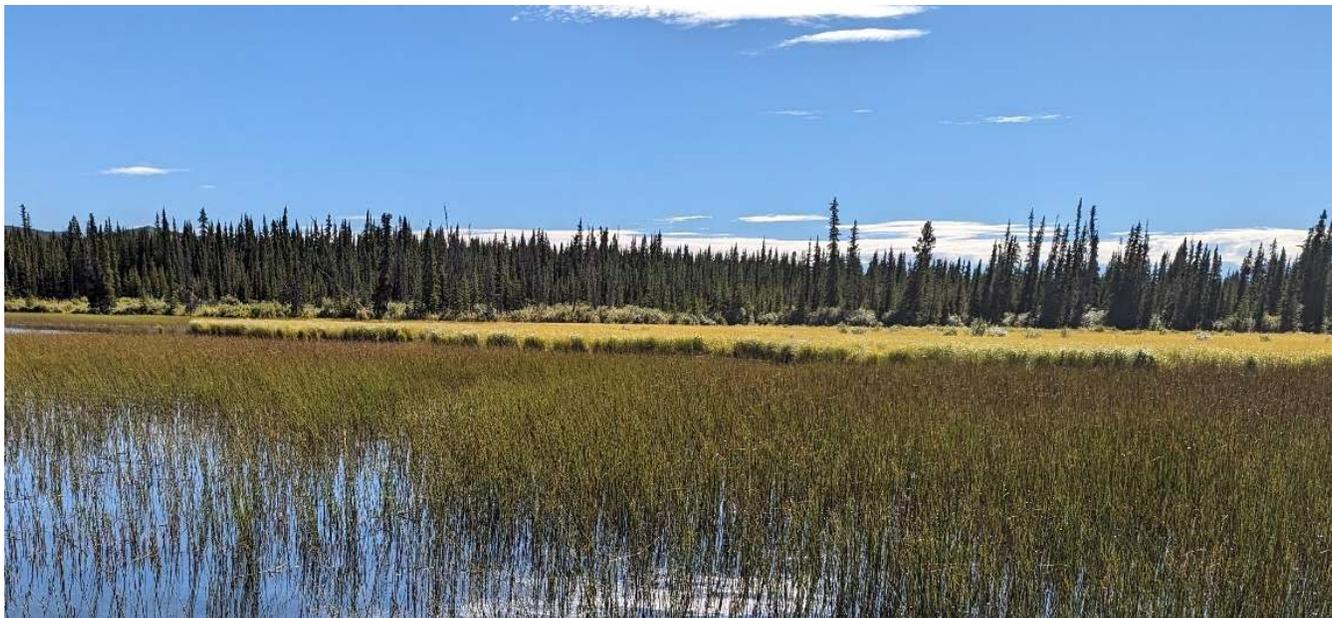
Photo 2. A view of the shoreline marsh habitat type and typical *Carex sp.* tussocks in the background of the photo with the horsetail emergent aquatic vegetation type in the foreground (August 26, 2023).

The emergent aquatic vegetation habitat type in Little Atlin Lake was characterized by high cover of water horsetail (*Equisetum fluviatile*) (Photo 2 and Photo 3). This emergent aquatic vegetation habitat was not easily distinguished from satellite imagery and was instead digitized using a combination of transect results, site photographs, and drone photographs taken from around the lake perimeter during 2023 fieldwork. The emergent vegetation type was commonly encountered on the lake and was frequently observed in sheltered bays and points, likely growing in similar areas each year and remaining wetted for the duration of the open-water season. The emergent vegetation community and occurred in water ranging between 0.6 m and 0.95 m deep (Photo 4). Submerged vegetation was also common in this type, including *Chara*, pondweeds (*Potamogeton* spp.), and common water-milfoil (*Myriophyllum sibiricum*).

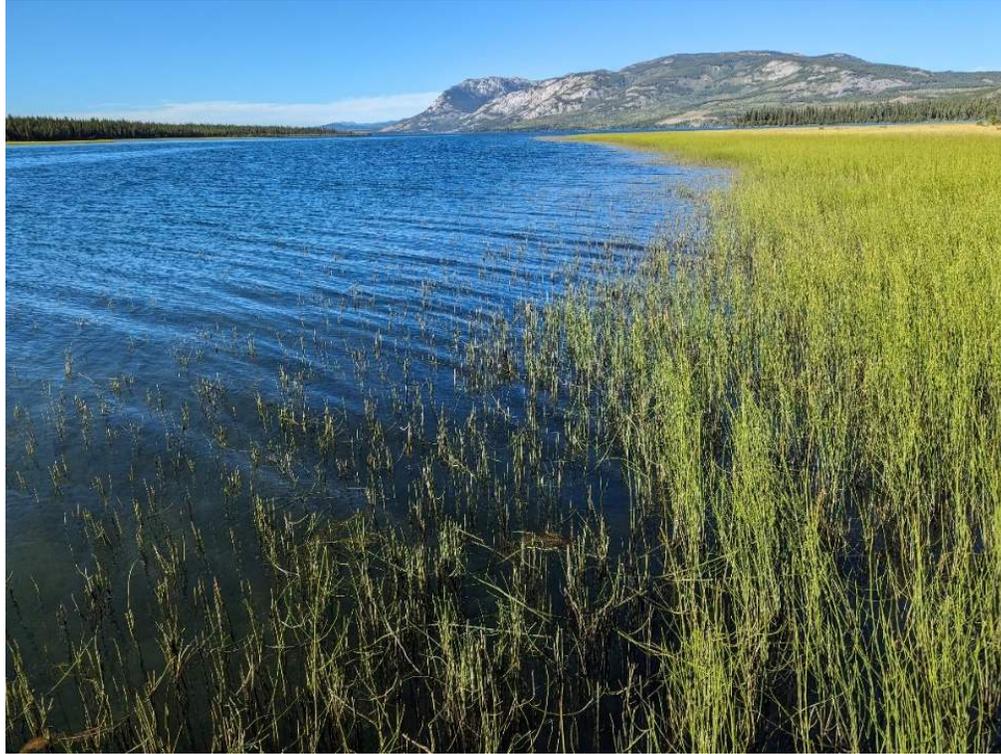
Photo 3. Emergent aquatic vegetation growing in patches along Little Atlin Lake (August 26, 2023).

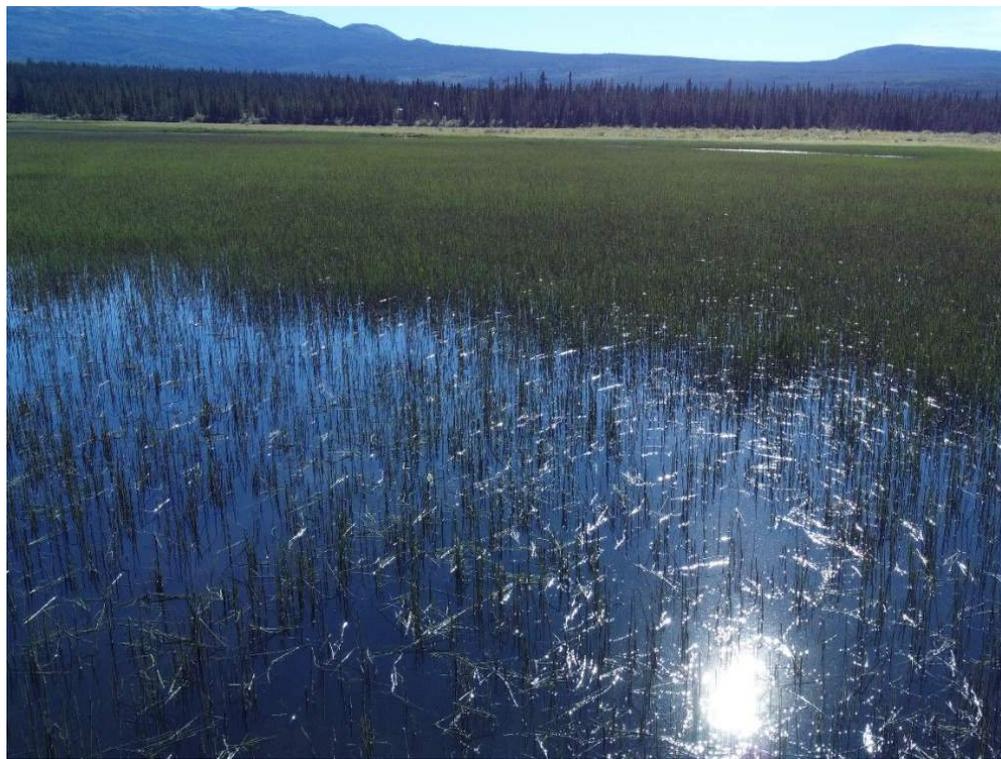
Photo 4. The emergent vegetation community in Little Atlin Lake showing standing water present throughout the horsetail stems which exist on a gradient of cover and density (August 27, 2023).

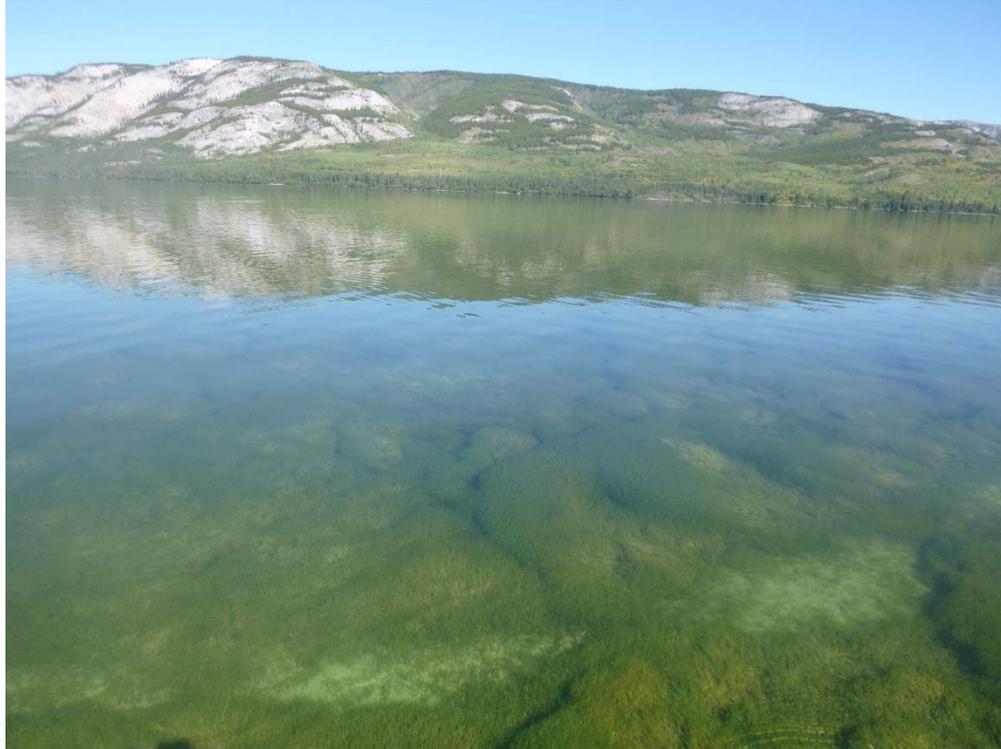
Photo 5. Typical healthy growth of *Chara* in carpets along the flats and benches of Little Atlin Lake (August 28, 2023).

These shallow benches were primarily comprised of dominant *Chara* growth (Photo 5 and Photo 7) or fines with little vegetation present (Photo 6 and Photo 8). In instances where these shelves occur at depths deeper than 0.75 m *Chara* growth was generally extensive and exhibited healthier and taller growth (Photo 5). In shallower water *Chara* appeared to be somewhat stunted (Photo 6). In most instances where a distinct shallow water (<2.5 m) shelf was present in Little Atlin Lake extensive *Chara* growth was present and either continuous or patchily distributed out to a depth of approximately 5.0 m. Functionally the tall or sparse stunted *Chara* dominated shallow bench habitat in Little Atlin Lake appears to function in a similar manner with little habitat complexity. The size of the shallow benches may provide separation between juvenile and adult northern pike rearing habitat in Little Atlin Lake as adults are expected to occur primarily outside of these flats with juveniles rearing on the shallow end of these flats along the margins of the emergent aquatic vegetation habitat type. Other species such as northern arrowhead (*Sagittaria cuneata*), thread-leaved pondweed (*Stuckenia filiformis*), and common water-milfoil occurred infrequently in this habitat type and at low cover (<25%) when present.

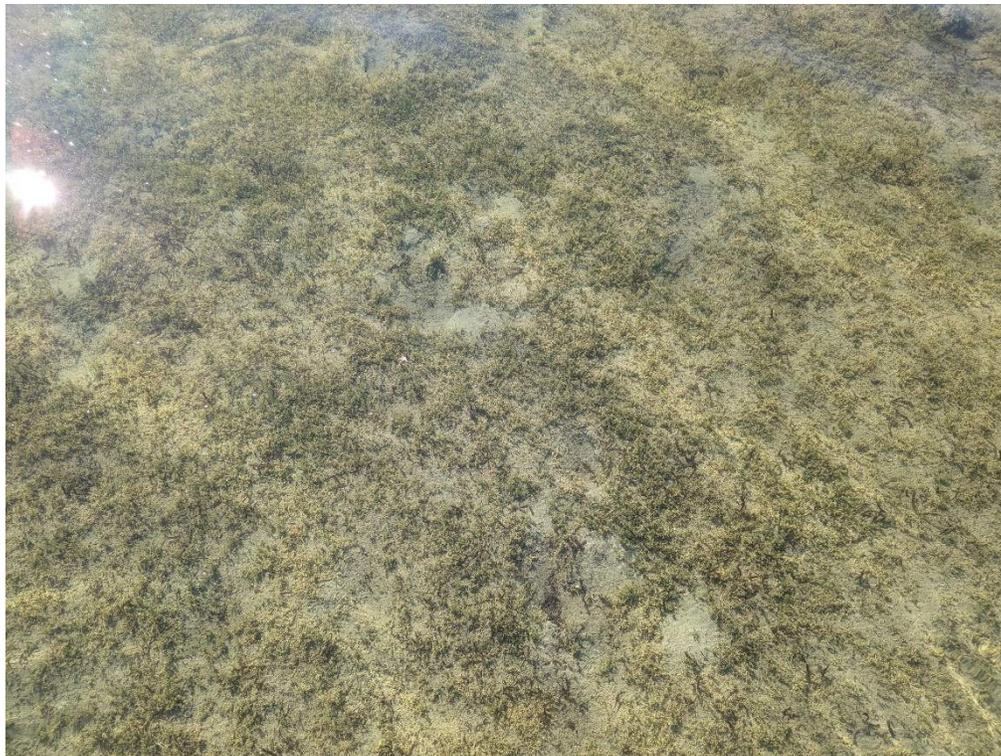
Photo 6. Example of sparse, stunted *Chara* grow on the shallow benches of Little Atlin Lake (August 26, 2023).

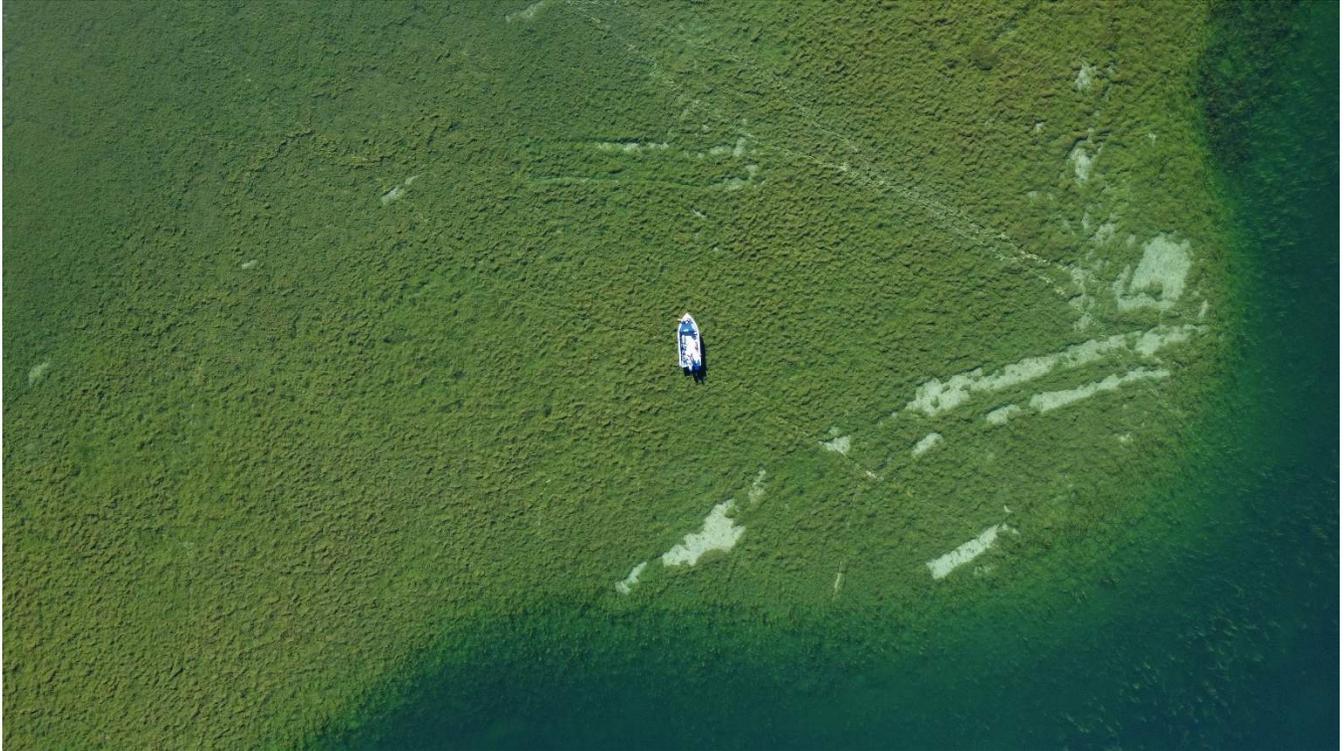
Photo 7. Aerial view of extensive *Chara* growth along a shallow bench (August 26, 2023).

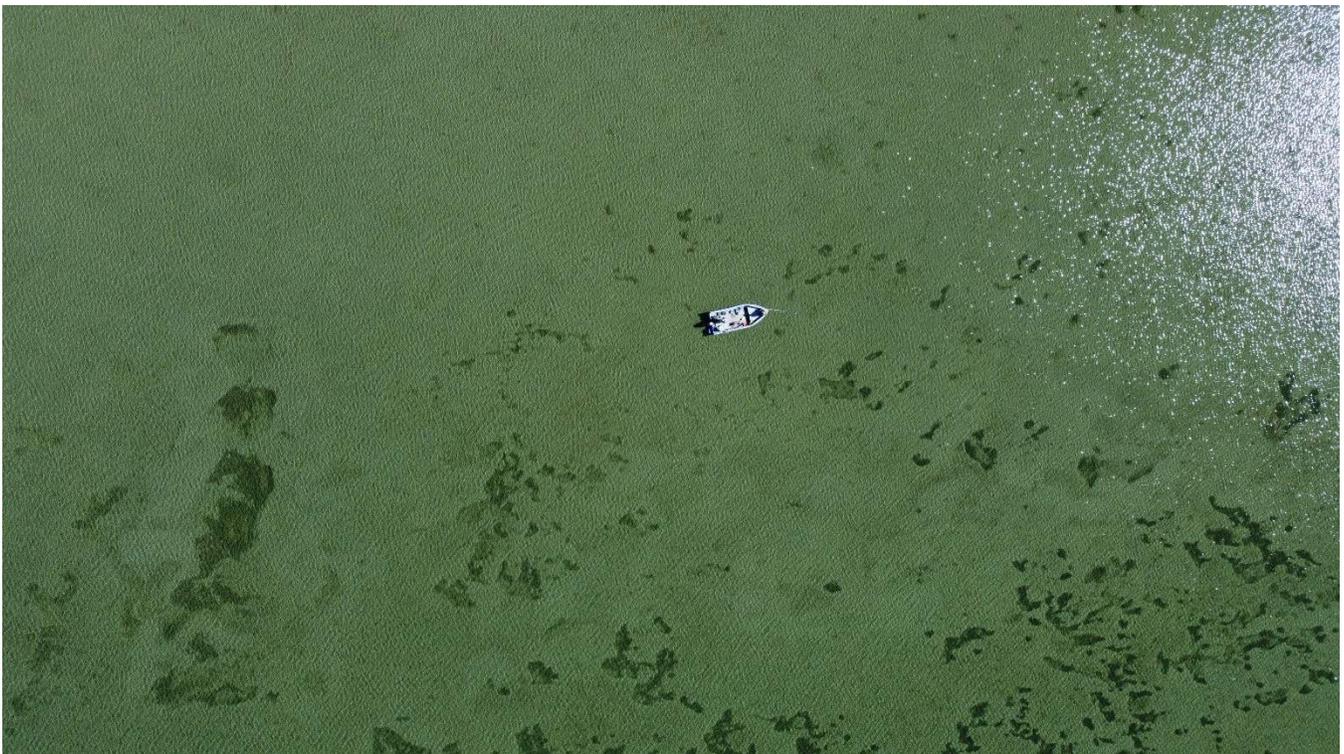
Photo 8. Aerial view of patchy and sparse *Chara* growth along a shallow bench (August 26, 2023).

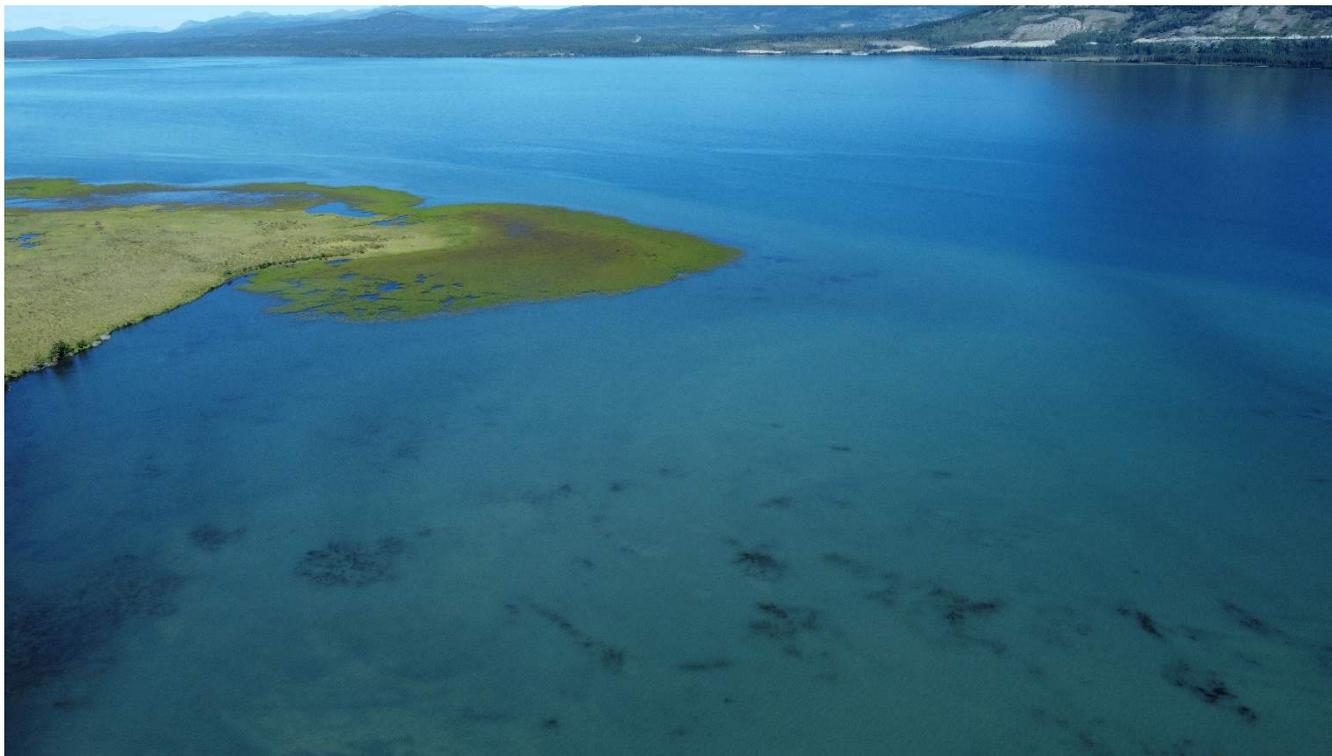
Photo 9. Aerial view of patches of medium aquatic vegetation (foreground) growing on a shallow bench in Little Atlin Lake (August 28, 2023).

There were some instances where the growth of other aquatic vegetation occurred in patches within the larger flats and bench habitat in Little Atlin Lake (Photo 9). Even in instances when a medium height vegetation community was present it was usually with a patchy distribution within a larger *Chara* flats community (Photo 10). The medium submergent vegetation communities could not be readily distinguished from imagery or photos as vegetation density and coverage were relatively low (<25% cover) on a broad scale. As such, this vegetation association/habitat type was not mapped during 2023 pike habitat mapping. However, it would likely represent micro-habitat associations and areas with higher than typical habitat utilization by juvenile and adult northern pike rearing in Little Atlin Lake. Vegetation in these patches was highly variable but often contained some combination of pondweeds and water-milfoil with *Chara*.

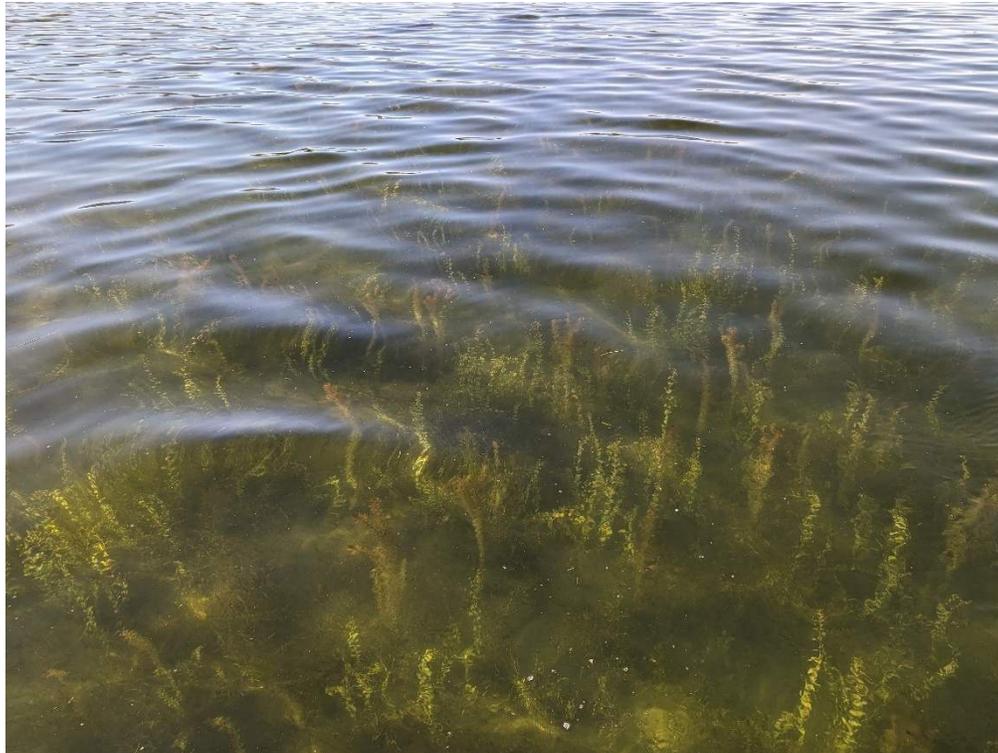
Photo 10. Closer view of a medium vegetation community on Little Atlin Lake encountered during fieldwork (August 26, 2023).

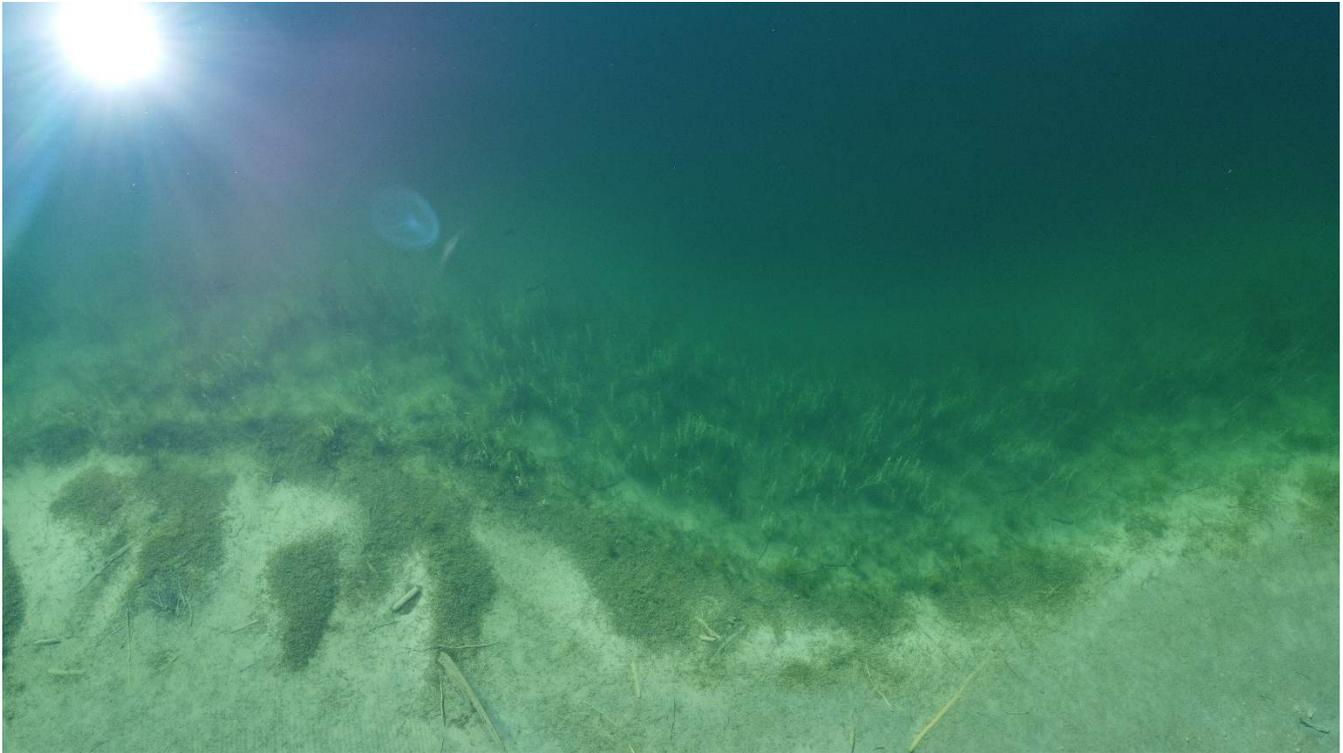
Photo 11. Aerial view of the tall submergent aquatic plant community growing along the top edge of a drop off in Little Atlin Lake (August 27, 2023).

The tall submergent aquatic vegetation habitat in Little Atlin Lake occurs regularly in a narrow 1.0 to 5.0 m wide band at the top or leading edge of drop offs, primarily formed at the edge of the shallow water benches present throughout the lake (Photo 11 and Photo 12). The tall vegetation community typically occurred at a depth of 4.0 m but could occur anywhere between 2.5 to 6.5 m water depth and appeared to be strongly associated with the start of a drop off. Adult northern pike were frequently observed associated with the tall submergent aquatic vegetation community during 2023 vegetation surveys. Species composition appeared to be rich and varied but was often dominated by some combination of white-stem pondweed (*Potamogeton praelongus*), Richardson's pondweed (*Potamogeton richardsonii*), thread-leaved pondweed, and common water-milfoil.

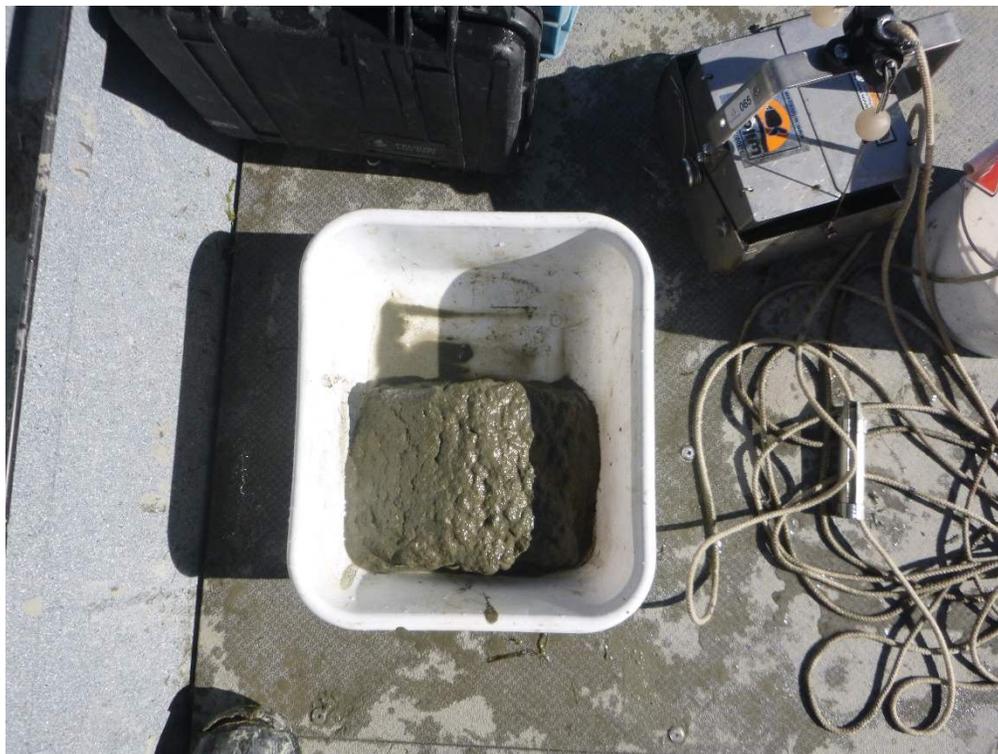
Photo 13. Typical Eckman grab sample of open water lakebed substrate (August 27, 2023).

In water deeper than 8.0 m, no to very sparse vegetation was collected using either the modified vegetation rake or an Eckman grab sampler. Beyond 8.0 m water depth the substrate of Little Atlin Lake was found to be incredibly consistent and was comprised entirely of differing densities of accumulated fines (Photo 13). When some texture was present in substrate samples it was largely due to gastropod shell fragments or small bits of *Chara* or moss embedded in the matrix of accumulated lakebed fines. As such all habitat in Little Atlin Lake deeper than 8.0 m was classified as open water habitat. However, it is recognized different depths likely correspond to different use and presence by the different species of fish present in the lake.

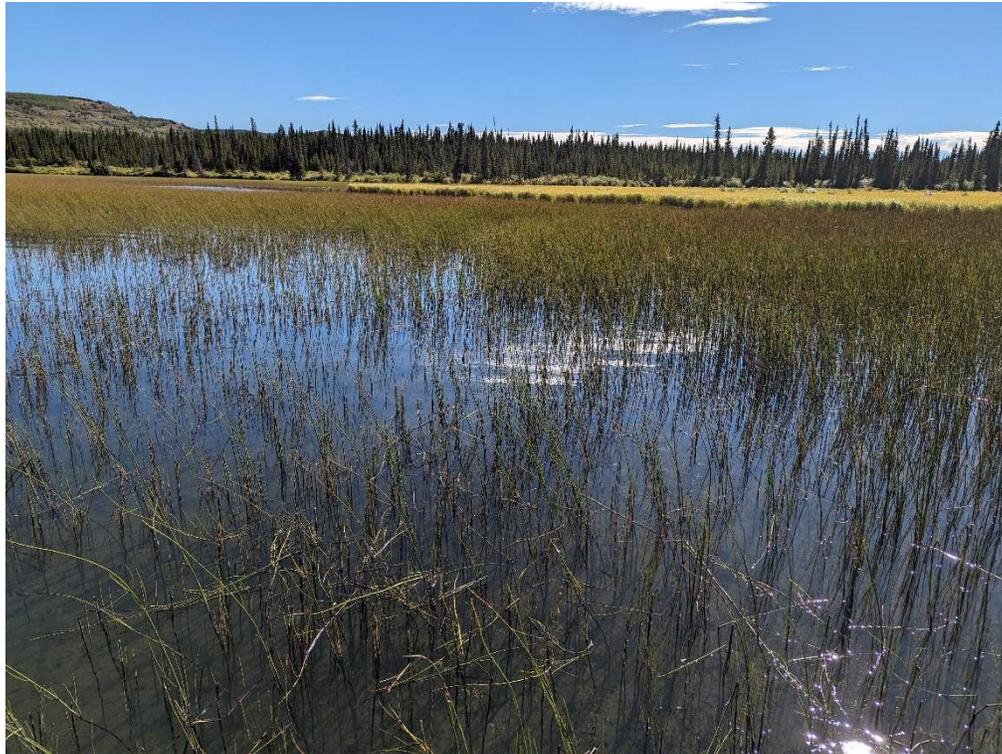
Appendix Photo A-1. Water horsetail (*Equisetum fluviatile*) dominated emergent zone (August 26, 2023).

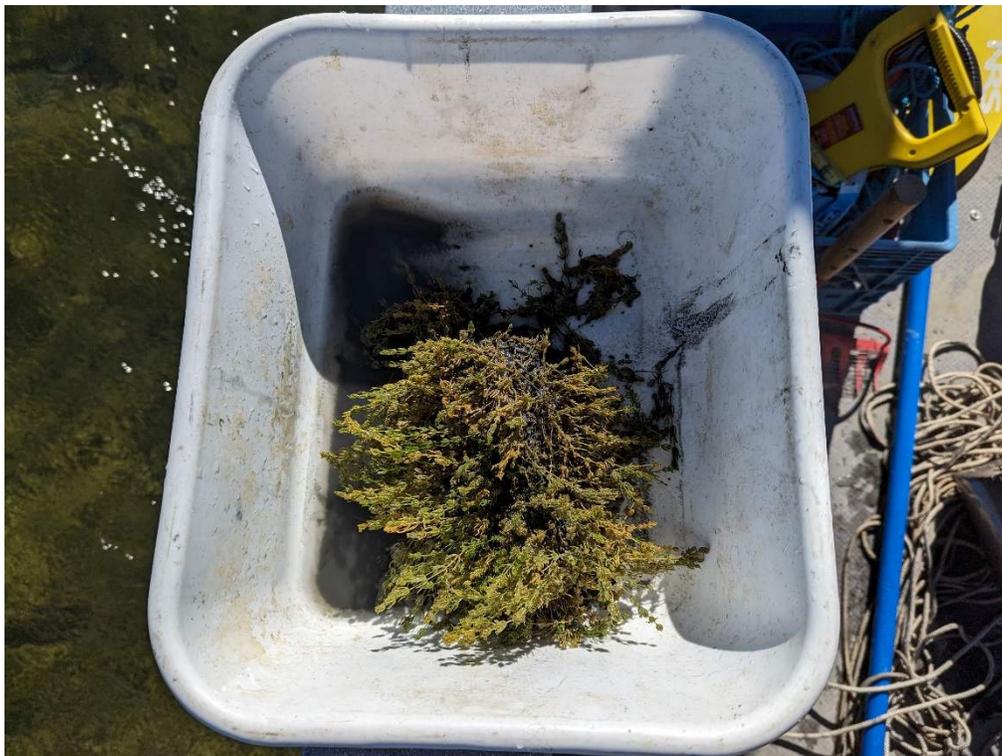
Appendix Photo A-2. *Chara* collected from an Eckman grab sample in Little Atlin Lake (August 26, 2023).

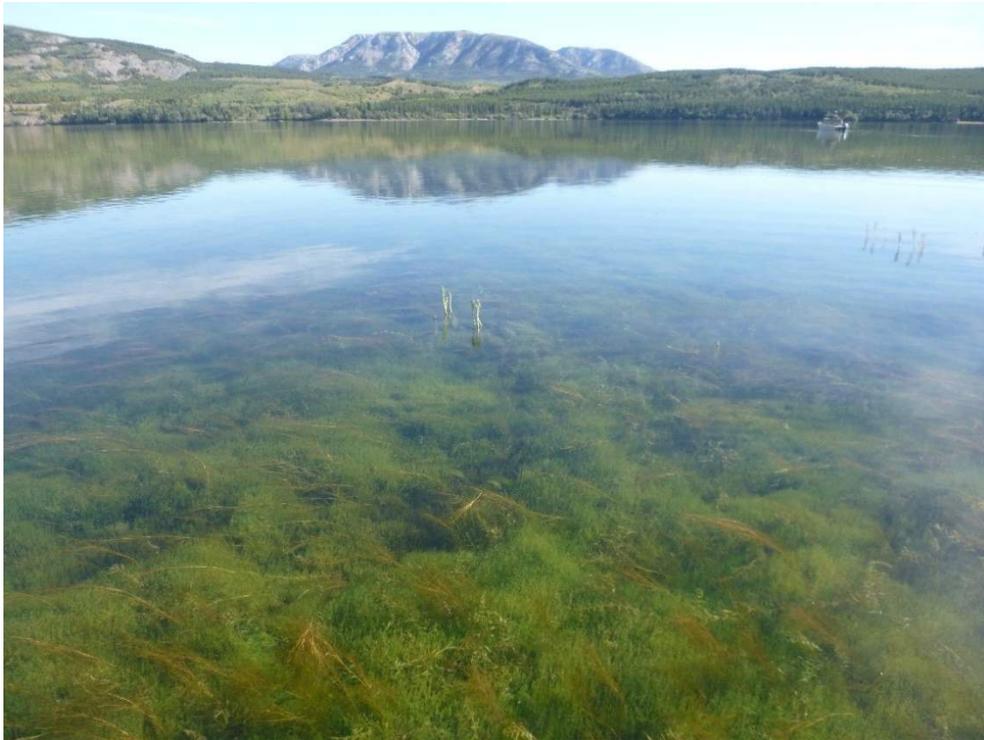
Appendix Photo A-3. A *Chara* carpet on a shallow bench in Little Atlin Lake with some other species present including Common mares-tail (*Hippuris vulgaris*) and Thread-leaved pondweed (*Stuckenia filiformis*) (August 27, 2023).

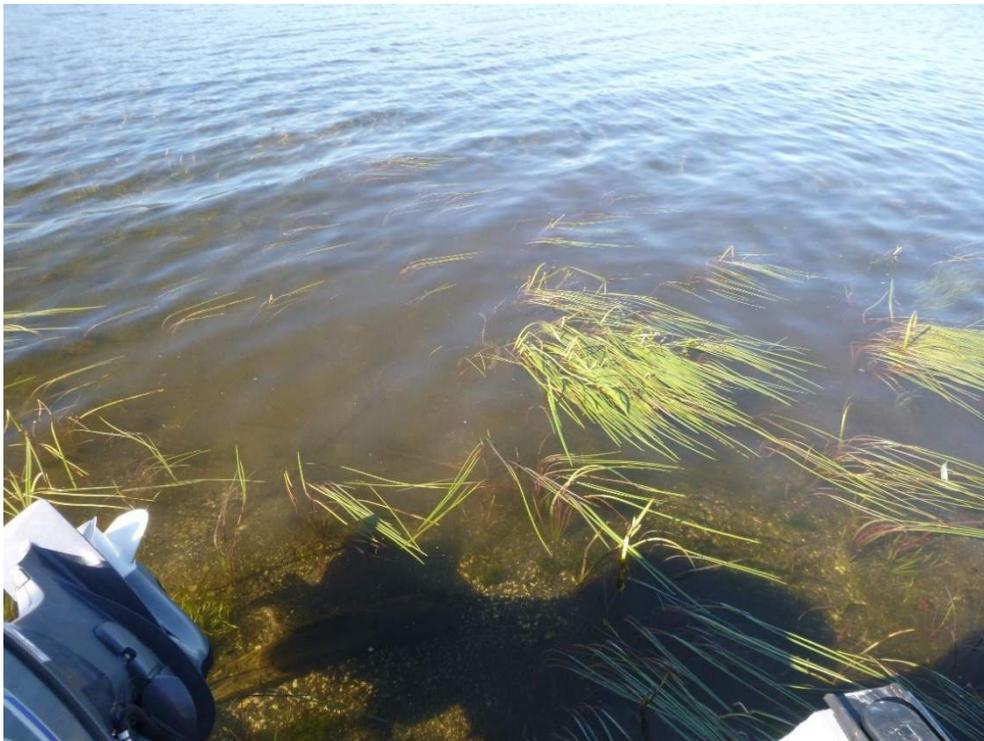
Appendix Photo A-4. Narrow bur-reed (*Sparganium angustifolium*) near the boat launch in Little Atlin Lake (August 28, 2023).

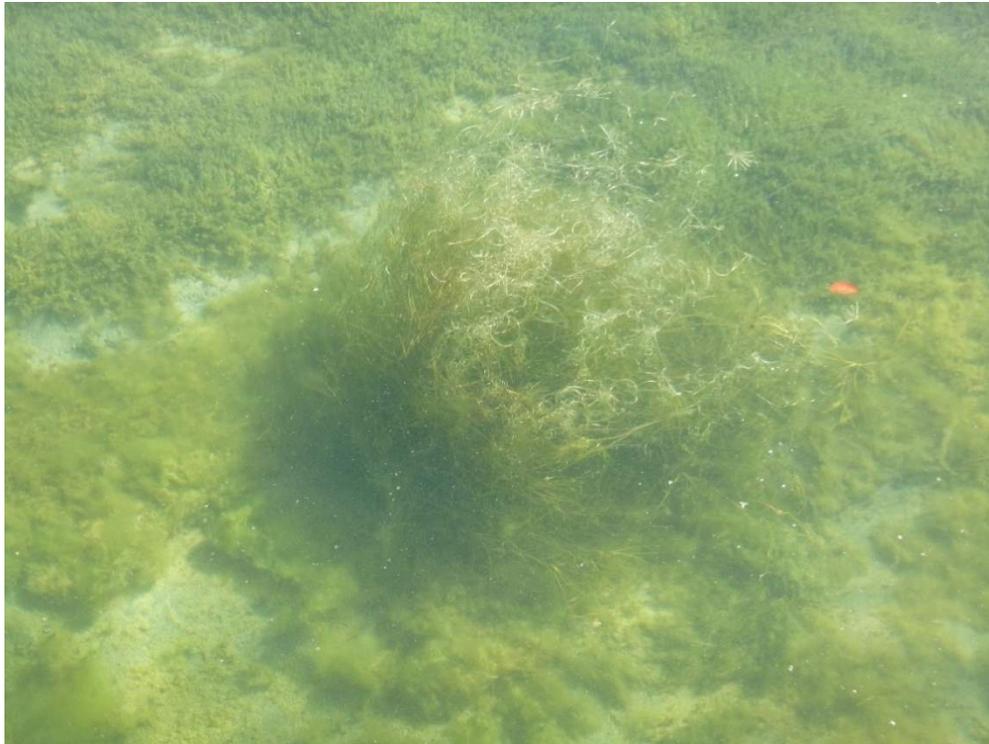
Appendix Photo A-5. Spiral ditchgrass (*Ruppia cirrhosa*). Ranked S1 (Critically Imperilled) in Yukon by the Yukon Conservation Data Center. Only seen in one location during this project (August 28, 2023).

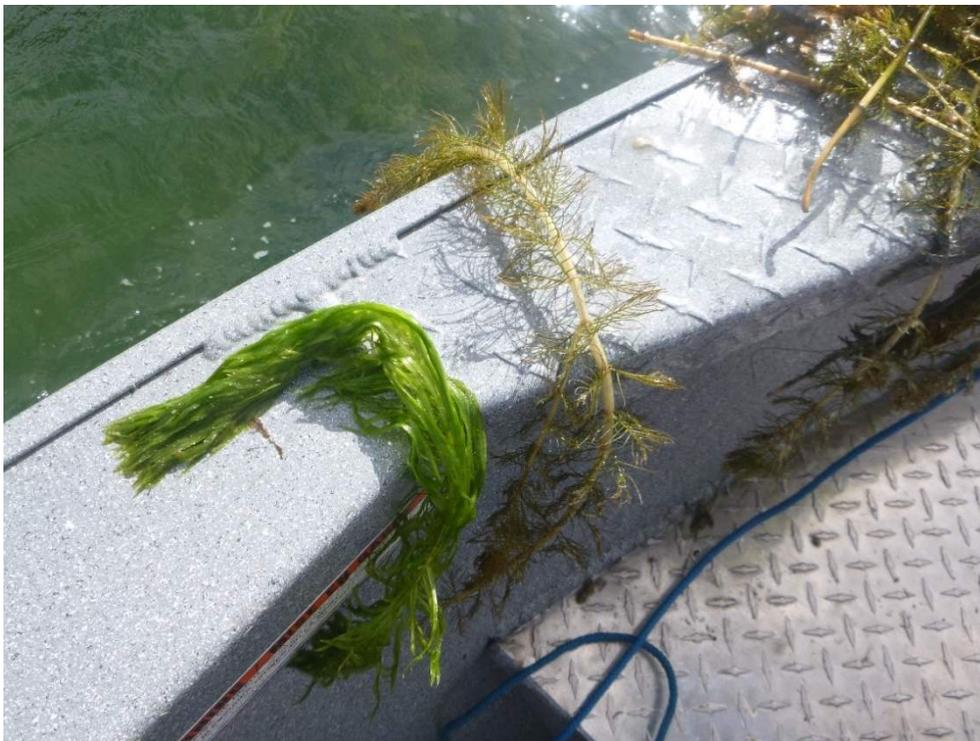
Appendix Photo A-6. Common mares-tail (left) and common water-milfoil (*Myriophyllum sibiricum*, right) collected from a rake drag (August 25, 2023).

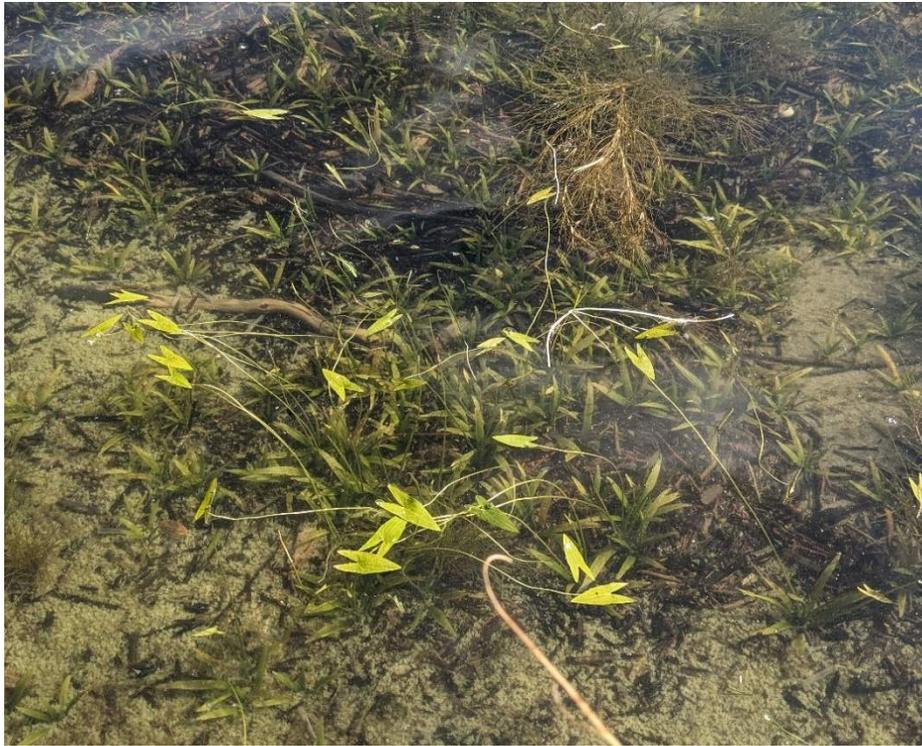
Appendix Photo A-7. Northern arrowhead (*Sagittaria cuneata*) was encountered in several locations. Ranked S3 (Vulnerable) in the Yukon by the Yukon Conservation Data Center (August 24, 2023).
